QUALITY TEST CERTIFICATE

Test report No. 20-15685 Rev.01

Equipment under test **Protos II** **4400C**
quantity 1 sample
labelled No. 22675000

Test program **Harmful gas test - Test Ke, method 4 according to IEC 60068-2-60**

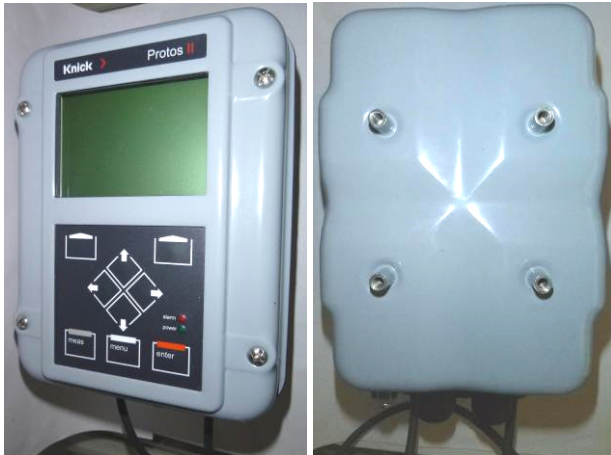
Picture 1
Protos II
state of delivery
before the harmful gas test

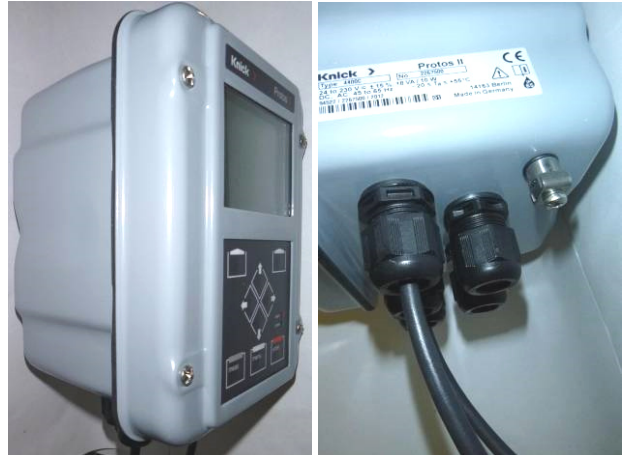
Picture 2
Protos II
state of delivery
before the harmful gas test

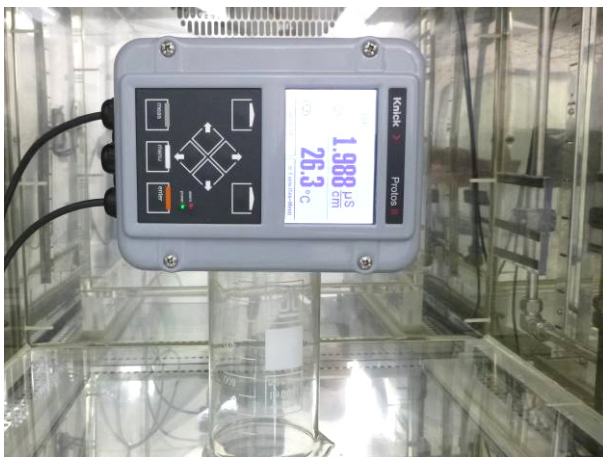
Picture 3
Protos II – operating with displayed values
in the corrosion test chamber K 350
at the beginning of the harmful gas test

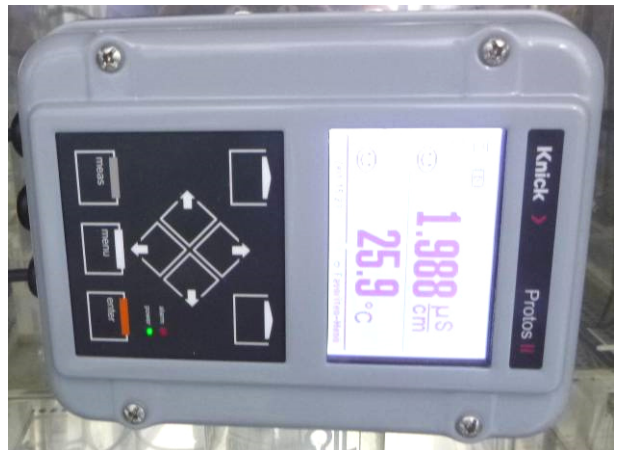
Picture 4
Protos II – operating with displayed values
in the corrosion test chamber K 350
at the end of the harmful gas test

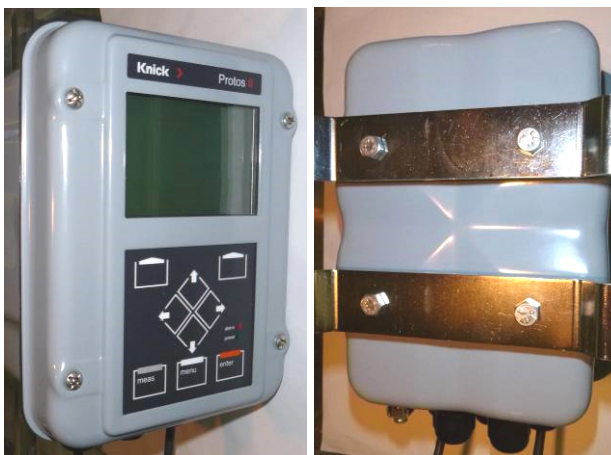
no damage or defects are visible, see appendix 2 – Test report 187/20 (13 July 2020), Before, during and after the test, the values displayed were within the plausible range; no significant deviations could be detected.

Picture 5
Protos II
without visible damage or defects
after the harmful gas test

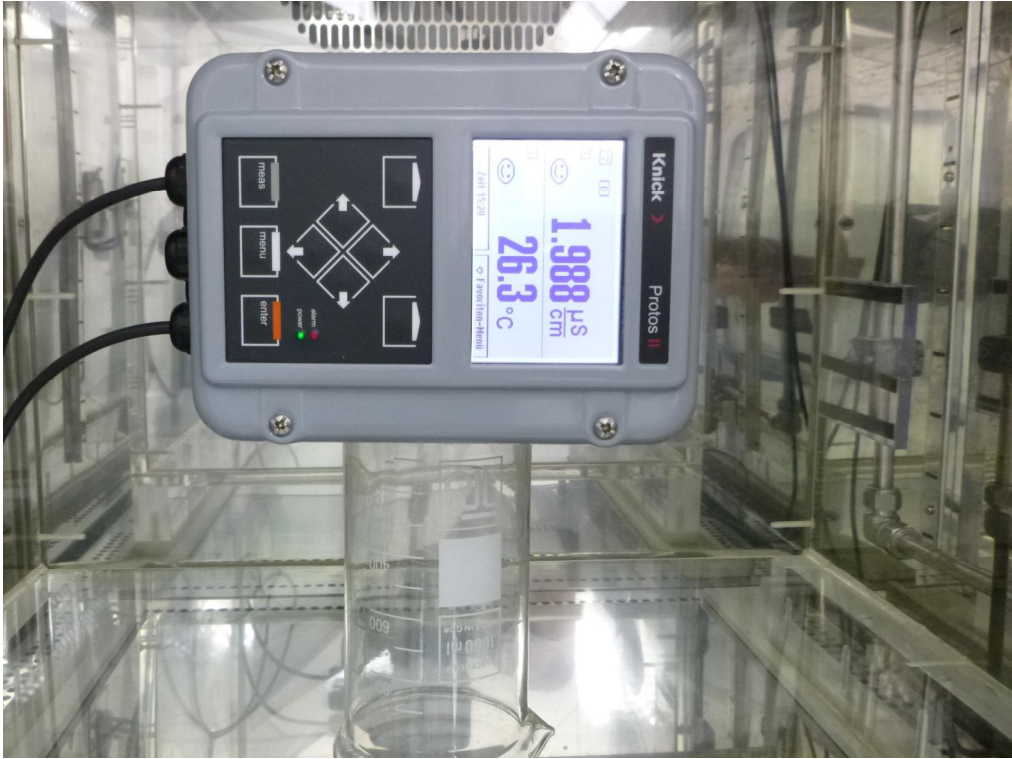
Damages or defects are not visible.

Figure 1 Exposition of test object at beginning of load

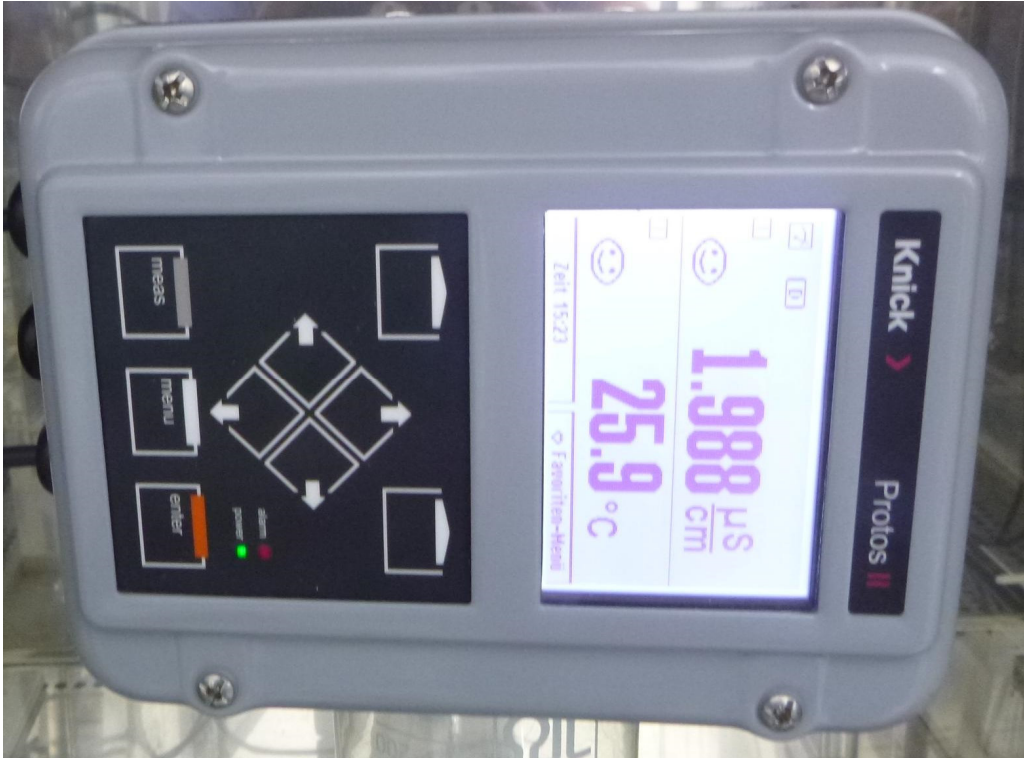
No changes are visible.

Figure 2 Test object at end of load after 10 d
